CENTRAL INTELLIGENCE AGENCY

INFORMATION REPORT

₩11 		SECRET SECURITY INFORMATIO	25X1A		
COUNTRY SUBJECT 25)	Poland 1. Dalmor Fish 2. Soviet Nava	ning Base al Supply Base	REPORT NO. DATE DISTR. NO. OF PAGES REQUIREMENT NO. REFERENCES	25X1A	
	THE	SOURCE EVALUATIONS IN THIS THE APPRAISAL OF CONTENT (FOR KEY SEE REV.	T IS TENTATIVE	25X1X	
SOURCE:		Stables has of	the Delmor Deen See Fi	shing Enterprise	
	agency in Swind just south of the begun in 1950 of pleted and a forestruction. The construction of the second seco	agency in Swinoujscie was located on Wollin Island facing the Swine Niver just south of its sharp bend Annex. Construction work on this base was begun in 1950 and by May 1952, approximately half of the basin was completed and a fish processing, refrigeration, and packing plant was in operation. The project was to be completed in 1955. The name of the construction company was Panstwowe Przedsiebiorstwo Budowlane (P. P. B.)			
	Point #1. Sor bri for was ern and siz	ting and Initial Proc. ck; approximately 120 its western end, whe three-stories high. side of the building was served by a RR seafter unloading and addrestor's office are director's office are	essing Shop: Reinfo

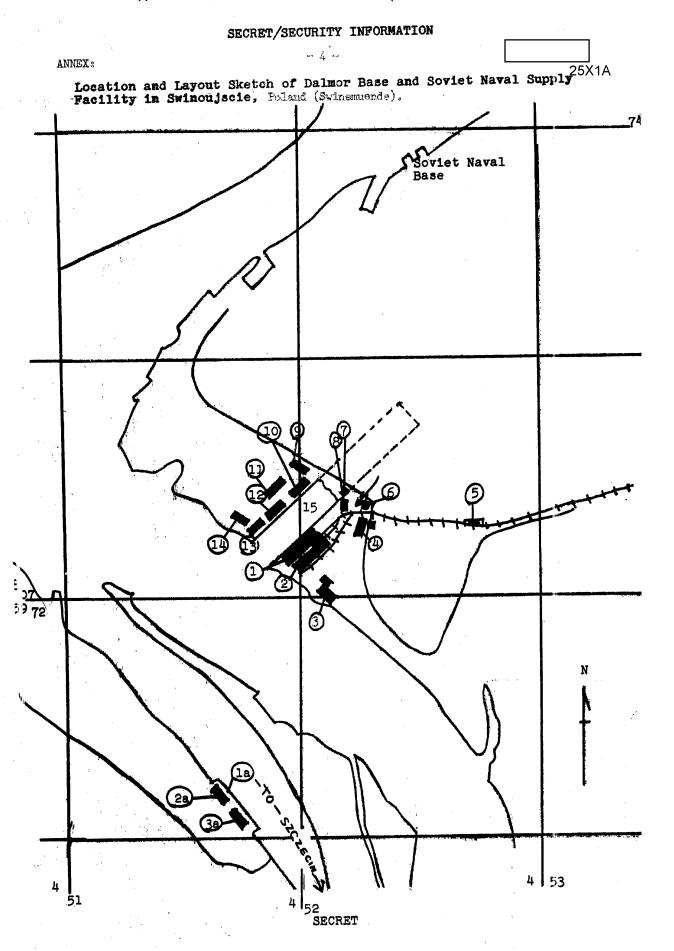
parallel to the processing building /Foint No. 17. There was also a RR spur at the NE end of the building which passed partially through the building in order to facilitate efficient loading of refrigeration cars. The basement was used for storing fish, packed in barrels, ready for shipment. From the SW end, a large pipe led past the processing building to the

- # 3. Ship Repair Shop: this consisted of two buildings; the larger, a one-story brick structure which housed a blacksmith shop, carpenter shop and an electricians' shop as well as welding equipment, and the smaller, a wooden, shed-type building. The quality of repairs done in the shop was very poor due to its limited equipment and lack of skilled workers. Vessels could not dock near this building and repairs were carried out either aboard ship or the ship was dismantled and parts were taken to the shop. Materials such as pipes, metals etc. were stored in the open, covered only by wooden roofs.

- # 4. Building: brick; used for storage of base construction materials; eventually to be used as the net factory.
- # 5. Net Factory and Repair Shop: concrete; with a loading ramp on the RR spur to the SW. This building was formerly a German torpedo storage facility.

- # 6. Main Entrance to the Base and Guardhouse.
- # 7. Mess Hall: temporary, wooden building.

- #8. Office of the Construction Company: temporary, wooden building
- # 9. 14. Buildings: wooden, temporary buildings; used as quarters for the construction workers and storage for construction tools and materials. It was said that eventually, underground fuel storage tanks would be built in this area.

- # 15. Fishing Basin: when completed, this basin was expected to measure 400 x 20 m. and 8 m. deep. The quays were to be of solid concrete. The finished quays were provided only with water connections and, as far as I know, it was not planned to erect cranes along this basin. Unloading operations were carried out with the help of five or six small, electric winches, mounted on carriages with portable cable connections, using the boom tackle of the trawlers as lifts. Fifteen trawlers would eventually be unloaded simultaneously in this basin.

- 4. The installation consisted of the following: /kemen/
 - Point # la. Concrete Quay: about 150 m. long; equipped with one mobile crane of heavy steel construction probably of about 25 tn. lifting capacity.

2a. - 3a. Buildings: red brick; two-stories high; each about 40 m. long.
